# Technical Newsletter

Issue TN24.05 Dec 2024

### TB 24.05 Morco open flued water heaters – **Important Safety Warning**

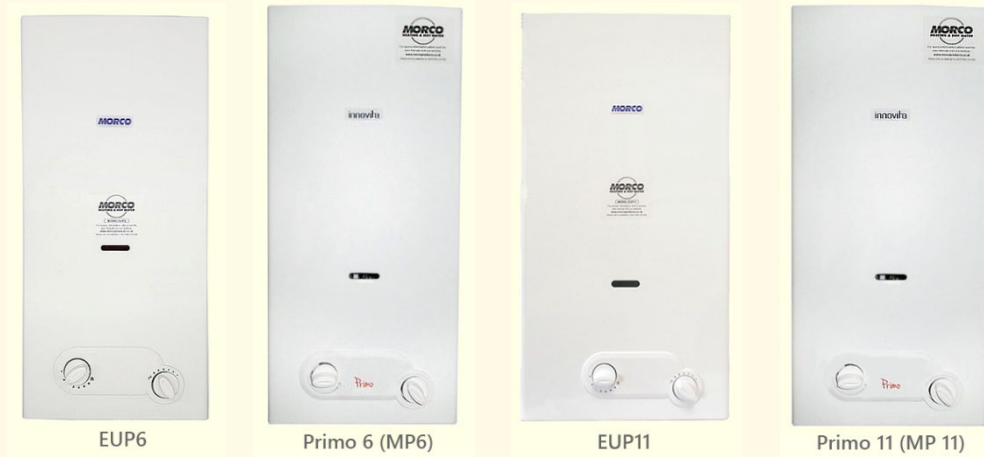
Morco has identified a potential fire risk on their Primo 6 (MP6), Primo 11 (MP11), EUP6 and EUP11 LPG open flued water heaters. The affected appliances were sold between 2018 and 2023.

It is estimated that there could be several hundred affected appliances on boats subject to BSS Examinations. Note that Primo models are also marked with the name Innovita (see images in Photos and Figures below). The **EUP11RS is not an affected model**.

These are the front face images of the affected models provided to the BSS by Morco. You can note some of the models have additional branding of Primo and Innovita.

Therefore, anyone who has one of the affected gas water heaters installed, **including those that have already had the safety upgrade**, must stop using the water heater immediately and isolate the gas supply to the appliance. Customers should then be guided to contact Morco to enable the company to verify the model, and if appropriate, either '**arrange a refund, or register for a free replacement product when one becomes available**'.

2. Guide your customer to follow the Morco advice to stop using the appliance and isolate the gas supply to it immediately and contact Morco straightaway using the link to the contact form on its **Important Safety Warning** web page <https://morcoproducts.co.uk/important-water-heater-safety-warning/> or call **01482 325456** or email [gaswaterheaters@morcoproducts.co.uk](mailto:gaswaterheaters@morcoproducts.co.uk) .
